The MIL Is Flashing with Loss of Power

AFFECTED VEHICLES

Year	Model	Trim Level	VIN Range
2018–21	Accord	ALL 2.0L Turbo with 10 A/T	ALL

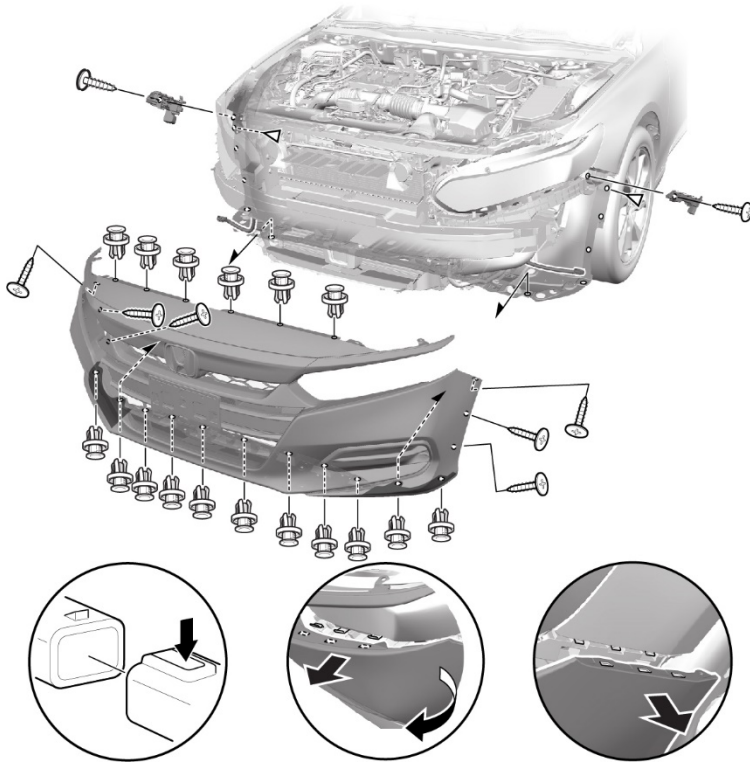
1. Remove the front bumper.

NOTE: There is no need to remove the wave radar or cover when removing the bumper.

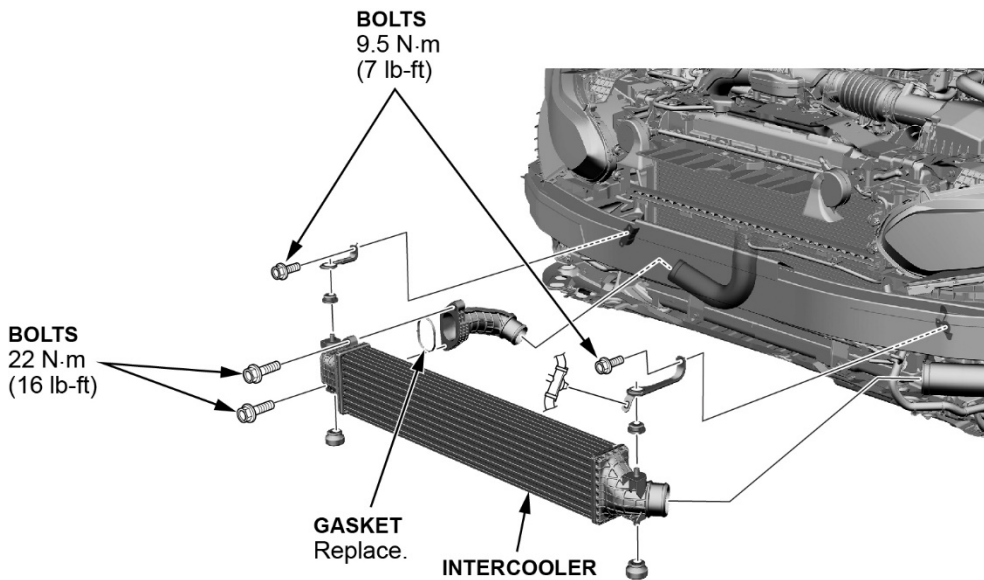
2. Remove the intercooler.

3. Install the new intercooler and gasket, and torque the two bolts mounting the intercooler to **22 N·m (16 lb-ft)** and the two bolts with brackets to **9.5 N·m (7 lb-ft)**.

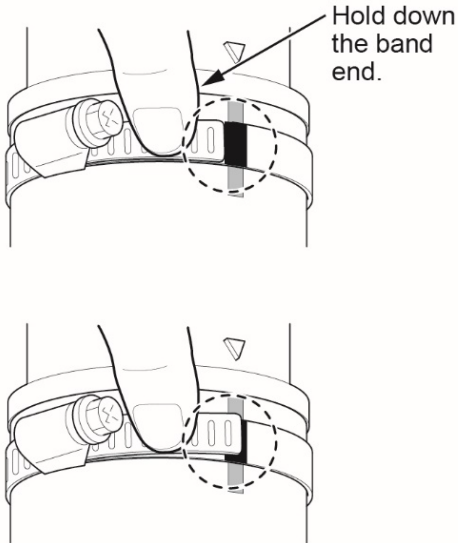
GOOD

The hose band end is **AT** or **WITHIN** the paint or hash mark on the hose band.

4. Tighten the hose bands to the specified condition below.

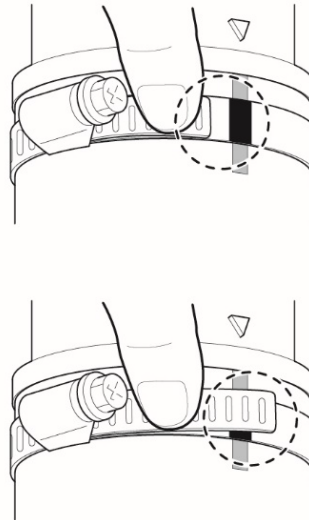
NO GOOD

The hose band end is **NOT AT** or **EXCEEDS** the paint or hash mark on the hose band.
