Applies To: **2008–09 Accord L4** – ALL

December 1, 2009

Blower Motor Is Noisy During Cold Weather

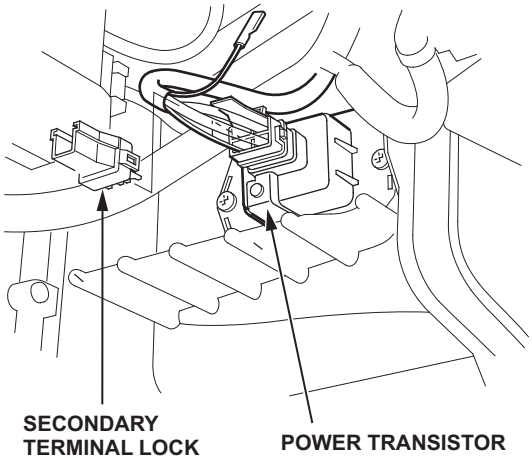
1. Remove the secondary terminal lock from the 4P connector on the blower motor power transistor, then remove the 4P connector. Closely inspect both sides of the 4P connector and its terminals:
   - If the connectors and the terminals on both sides of the 4P connector are OK, go to step 3.
   - If the power transistor side of the 4P connector is damaged, or if any of the terminals in the power transistor are bent or loose, replace the power transistor, then go to step 4.
   - If the wire harness side of the 4P connector is damaged, or of any of the terminals in that connector are bent or loose, go to step 2.
