Surge, Hesitation, or Judder on Light Acceleration from a Stop

The continuously variable transmission (CVT) needs hardware and software updates.

Install the updated transmission valve body kit, and update the PGM-FI software.

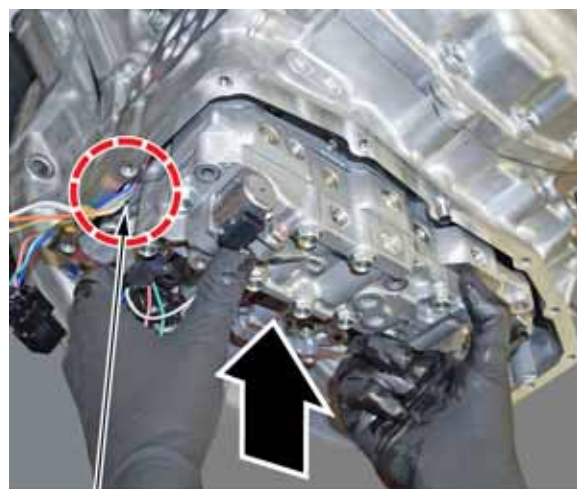
8. Install the new lower valve body assembly and the bolts. Tighten them in a crisscross pattern in at least two steps

- Do not pinch or damage the solenoid wire harnesses.
- While installing the new valve body assembly, be careful not to damage the pipes or the O-rings.
