2005 ACCORD - Interior Trim Removal/Installation - Pillar Areas

4-door-C-Pillar Trim - With Side Curtain Airbags ('04-07 models)

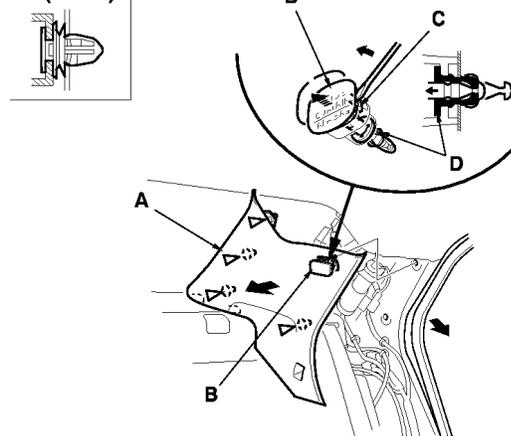
Fastener Locations

2. Remove the C-pillar trim (A).

-1 Pry the C-pillar cap (B) out until it is stopped by the hooks (C). Release the hooks and pull the cap out of the grommet (D). Discard the cap.

▷ : Clip, 4
(White)

3. Install the trim in the reverse order of removal, and note these items:

- Check if the clip is damaged or stress-whitened, and if necessary, replace it with new one.
- Do not reuse the C-pillar cap; always replace it.
- If the side curtain airbag has deployed, replace the C-pillar trim with new one.
- To prevent the side curtain airbag from accidentally deploying, removed trim pieces should be checked for these kinds of damage:
 - Any cracks, deformations, or press-whitenings in the C-pillar trim (A)
 - Any cracks, or press-whitenings in the grommet and clip seating surfaces (B)
 - Bent or broken grommet (C)
- Replace any damaged parts with new ones.
- Make sure the top of the trim overlaps with the headliner correctly.
- Push the clips into place securely.
